North Coast Regional Water Quality Control Board

Report for March 24, 2020 Consent Inspection of Humboldt County Assessor's Parcel Numbers 208-221-008, 208-221-015, and 208-221-016

Report of March 24, 2020 Inspection

CIWQS Place ID 824460

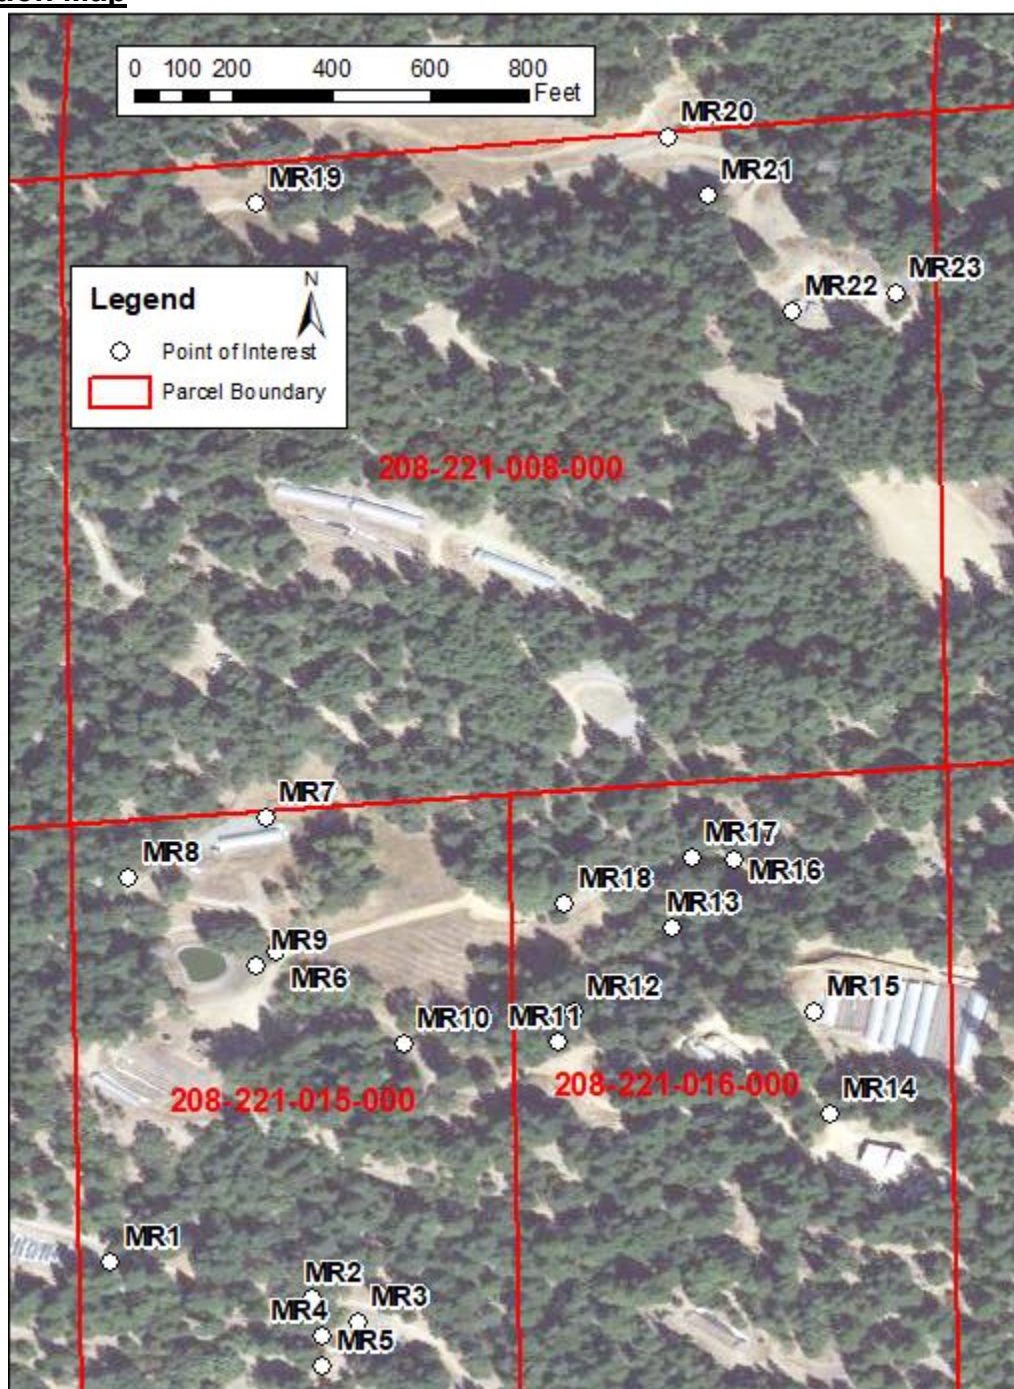
Figure 1: Map of Property, including Inspection Points of Interest

On March 24, 2020, I inspected the subject property. Figure 1, above, is a site map showing inspection points discussed below.

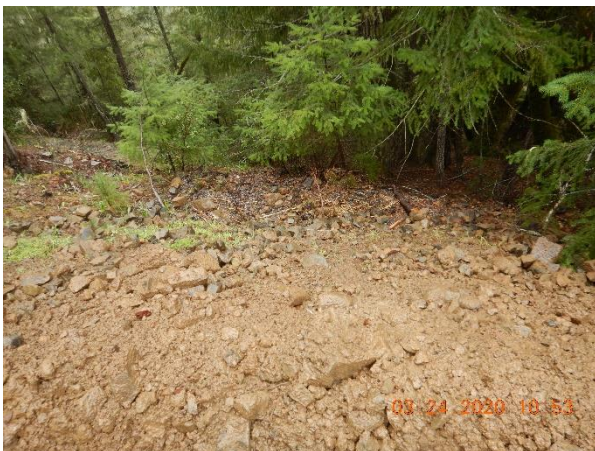
MR1: I observed loose fill and potting soil that had been pushed over the edge of a recently graded flat (Photo 1).

8. Pesticides: I did not observe pesticides.
9. Petroleum products and other chemicals: I did not observe petroleum products or other chemicals.
10. Cultivation-related wastes: I observed potting soil pushed over a hillside.

Photo 1 – Potting soil pushed over hillside

4. Store and contain all potting soil, cultivation-related waste, and chemicals, including pesticides and petroleum products, properly to prevent spillage and potential for migration/transport into receiving waters.

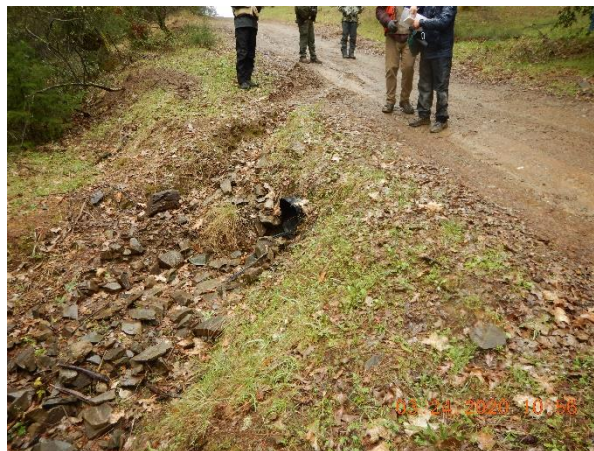
MR2: I observed a culvert stream crossing receiving road runoff (Photo 2).

Photo 2 – Outlet of culvert. Stream crossing receives runoff from road

1. Retain a licensed professional to develop a workplan and schedule to:
 - a. Evaluate all stream crossings for capacity to convey the 100-year flood flow, including debris and sediment loads, and to replace the stream crossings as necessary.

- b. Improve access road alignment, surfacing, and drainage to minimize erosion and sediment transport. Hydrologically disconnect access roads and road ditches from watercourses.

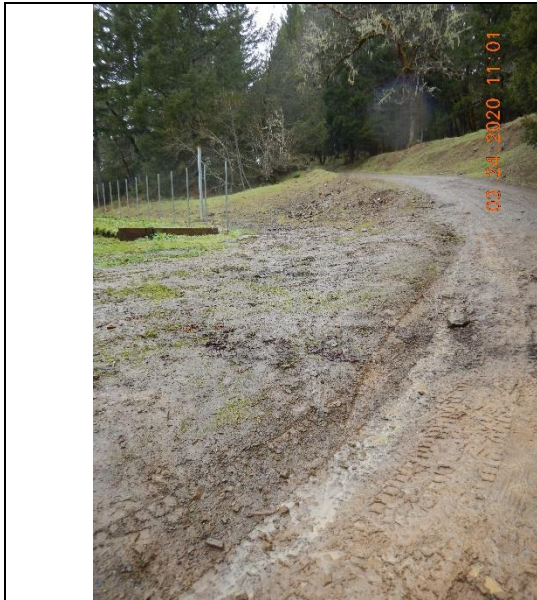
MR3: I observed a cultivation area overgrown with weeds adjacent to a watercourse (Photo 3).

Photo 3 – Cultivation area at base of road

2. Relocate all cannabis-related infrastructure outside of the applicable riparian setback requirements per the CANGO.
3. Submit design plans, construction schedule, and other relevant information to the Regional Water Board through the 401 Water Quality Certification process prior to starting work in surface waters. Work may not start until authorization is received from the Regional Water Board. See 401 Water Quality Certification application here:
https://www.waterboards.ca.gov/northcoast/water_issues/programs/cannabis/pdf/200204/RB1_Cannabis_WQC_401_App.pdf

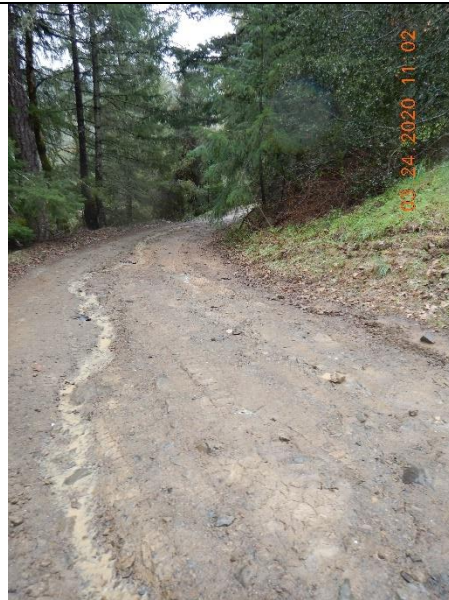
MR3: I observed the watercourse mentioned in **MR4** diverted down a road (Photo 4).

Photo 4 – Watercourse diverted down road

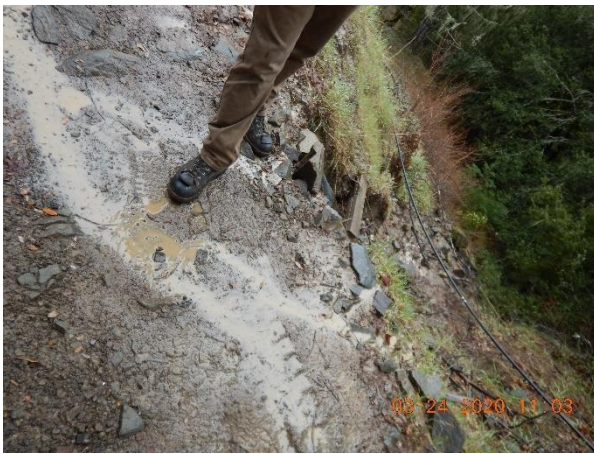
MR5: I observed a dirt ford stream crossing (Photo 5).

Photo 5 – Dirt ford stream crossing

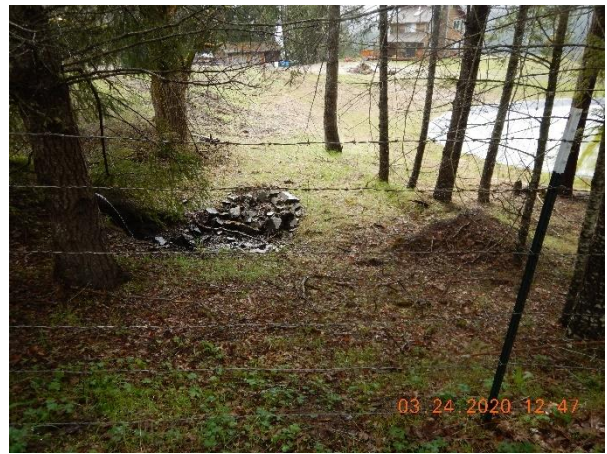
MR6: I observed the base of a muddy road that was covered in rills. Approximately 20 feet away, I observed a pond (pond 1). I observed approximately 180 feet of 10-inch diameter plastic piping discharges adjacent to the pond (Photo 6).

Photo 6 – Pipe discharges adjacent to pond 1

- c. Remove the ponds and restore associated impacts to the watercourse channels and riparian areas as necessary.
 - d. Assess the cultivation flats for stability and compliance with riparian setbacks and improve or remove unstable/ non-compliant flats. Dispose of all development and restoration-related earthen spoils in a manner to prevent/minimize transport and delivery to receiving waters.

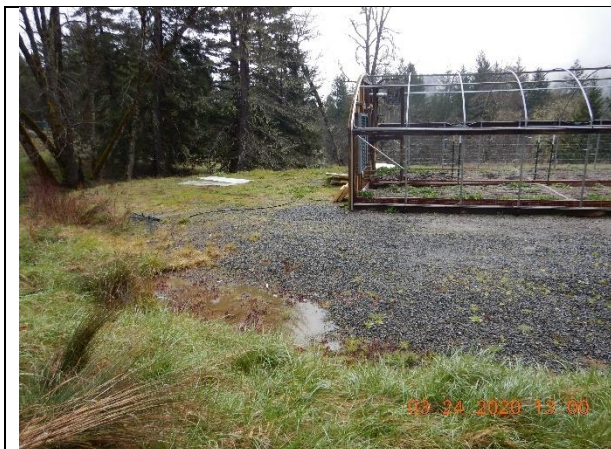
MR7: I observed a cultivation area with a seepy cutbank (Photo 7). Water from the seep channelizes and discharges to the pond at **MR8** (pond 2).

Photo 7 – Seepy wetland area in forefront of cultivation area

- e. Conduct a forensic wetland delineation, per U.S. Army Corps protocols, of areas **MR7** and **MR12** and submit a wetland restoration plan which includes a project description, goal of restoration, implementation plan and schedule, plan for monitoring and site maintenance following restoration, and contingency measures addressing the diversity index of wetland/ non-wetland native plant species occurring on the Property. The plan should include proposed mitigation to address the temporal and permanent losses of wetland value and function.

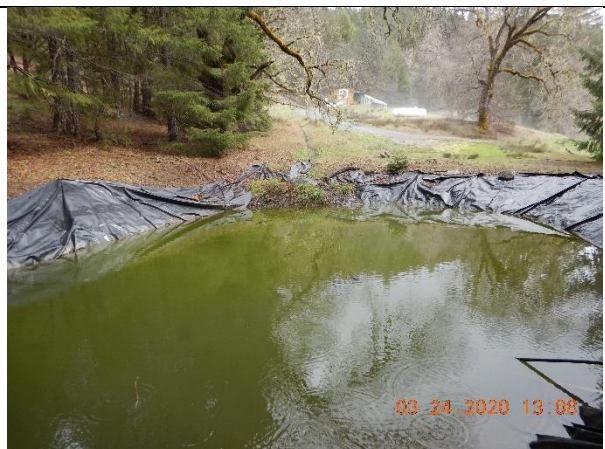
MR8: I observed a pond (pond 2) that receives flow from a seep and had a black plastic outlet pipe (Photo 8).

Photo 8 – Seep discharges via channel from cultivation area (top of hill) to pond 2

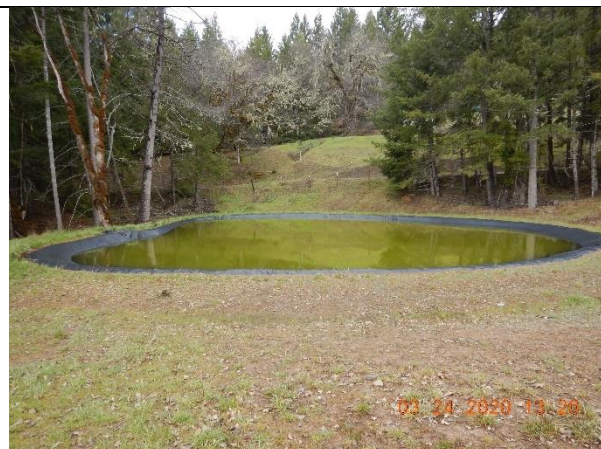
MR9: I observed a pond with green water adjacent to the head of a watercourse (Photo 9). The pond discharges to the watercourse via a tarped overflow channel and a culvert (Photo 10).

Photo 9 – Pond 3

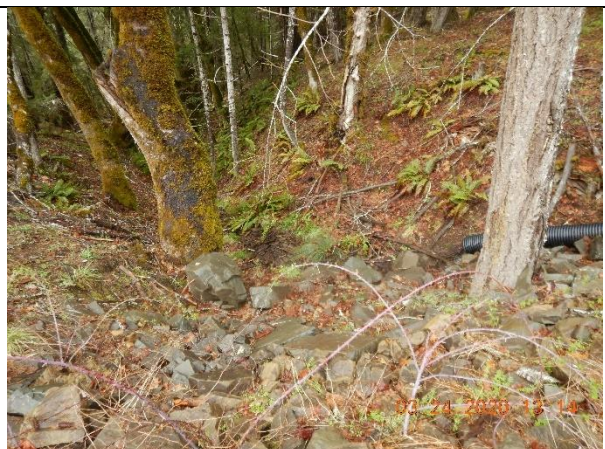
Photo 10 – Pond 3 overflow culvert discharges to watercourse

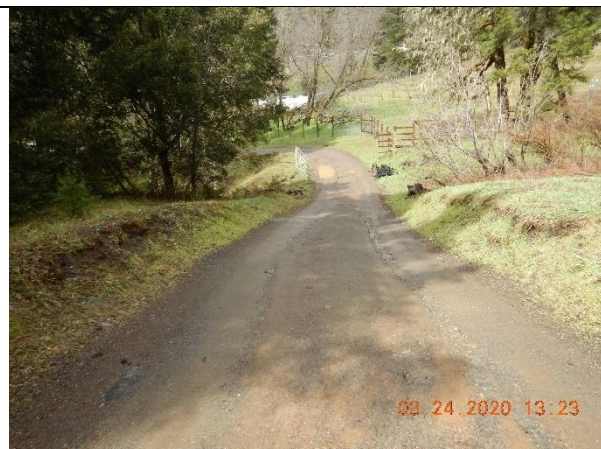
MR10: I observed a culvert stream crossing at the bottom of a hill that appeared to be functioning (Photo 11).

Photo 11 – Culvert stream crossing at base of road

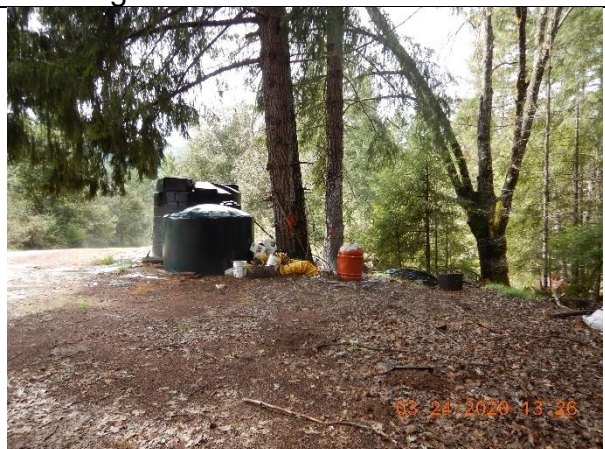
MR11: I observed a leaking waterline adjacent mixing tanks (Photo 12).

Photo 12 – Leaking waterline

8. Regularly inspect water lines for leaks and immediately repair any leaks found.
9. Work with CDFW and the State Water Resources Control Board's Division of Water Rights (DIV) to determine and secure any applicable permits or licensing required for surface water diversion, storage, and use on the site.

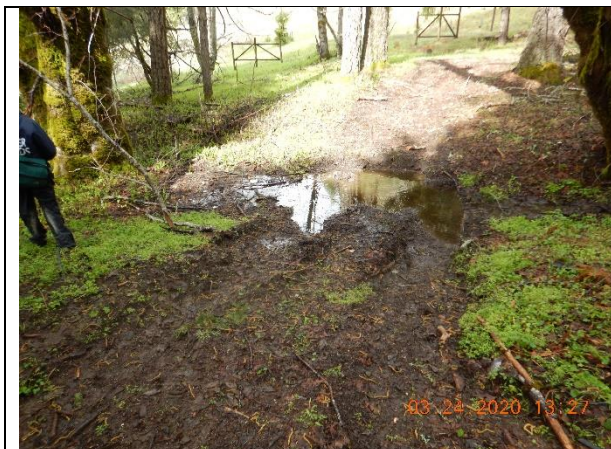
MR12: I observed a dirt ford stream crossing near a wetland area (Photo 13). A property representative stated the road stretch will be decommissioned.

Photo 13 – Dirt ford stream crossing

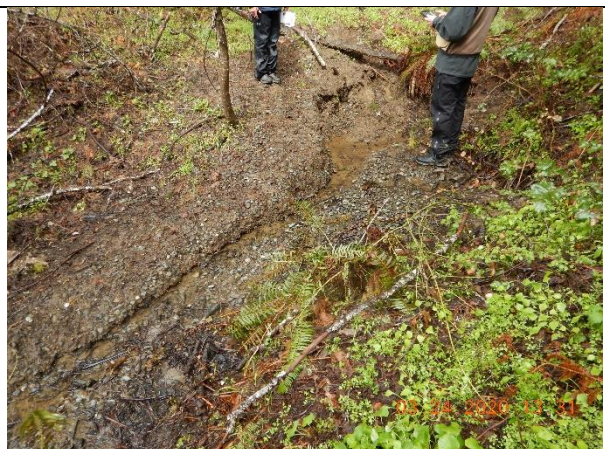
MR13: I observed a diversion point in a watercourse. The watercourse had been dredged to install the POD (Photo 14).

Photo 14 – Dredged area of watercourse for diversion point

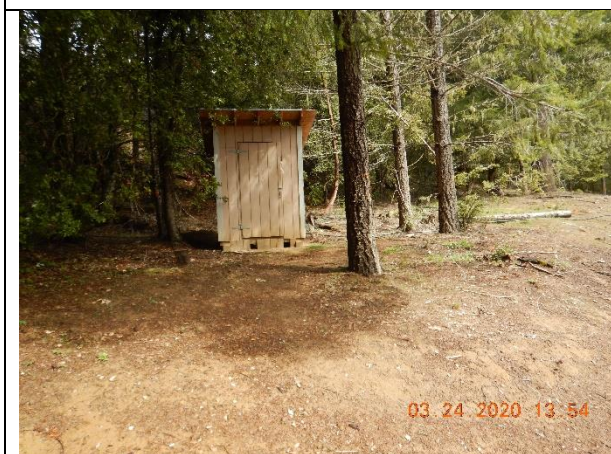
MR14: I observed an outhouse that discharged human waste to ground (Photo 15).

11. Refuse and human waste: I observed an outhouse that discharged to ground.

Photo 15 – Outhouse

7. Discontinue use of and dismantle any outhouse/pit toilet features and work with Humboldt County to ensure that all domestic and human wastes are collected and disposed of consistent with applicable County requirements.

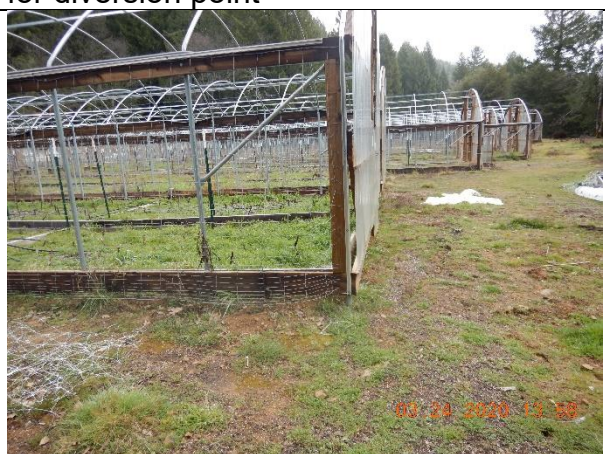
MR15: I observed an approximately three-quarter acre cultivation area on top of a ridge. I observed signs of instability including cracks on the flat (Photo 16).

Photo 16 – Cultivation area on top of ridge

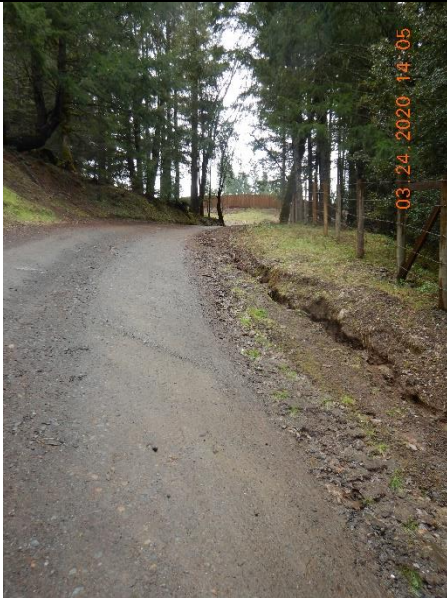
MR16: I observed an inboard ditch on the access road to the ridge cultivation area **MR15** (Photo 17). **MR16** marks the top of the inboard ditch.

Photo 17 - Inboard ditch

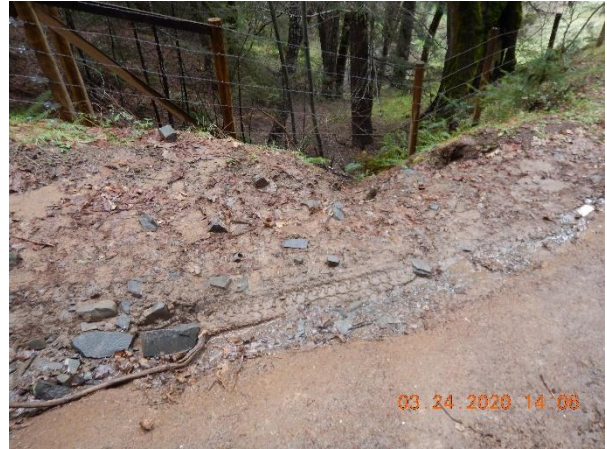
MR17: I observed the discharge point of the inboard ditch that started at **MR16** (Photo 18).

Photo 18 – Inboard ditch discharge point to hillside

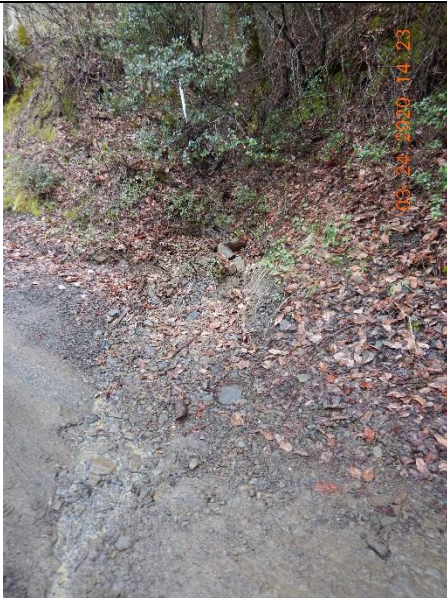
MR19: I observed a culvert stream crossing receiving flow from an inboard ditch (Photo 19).

Photo 19 – Culvert stream crossing with evidence of overflow

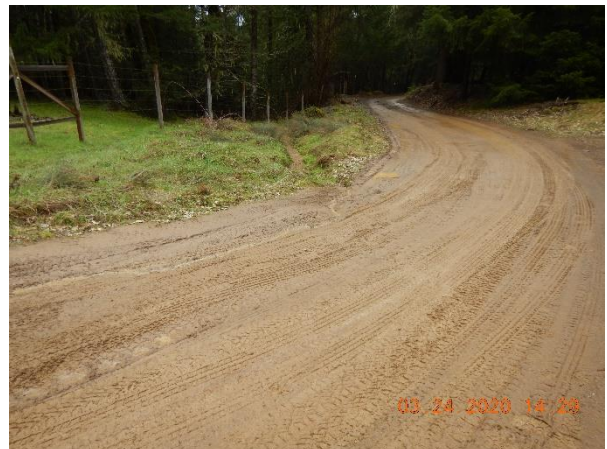
MR20: I observed a spring at the top of the inboard ditch mentioned in **MR19**. The spring historically crossed the road via a culvert and discharged to a pond. The culvert was blocked/ not functional causing the spring to divert down the road (Photo 20).

Photo 20 – Spring diverted down road, creating channel through grass

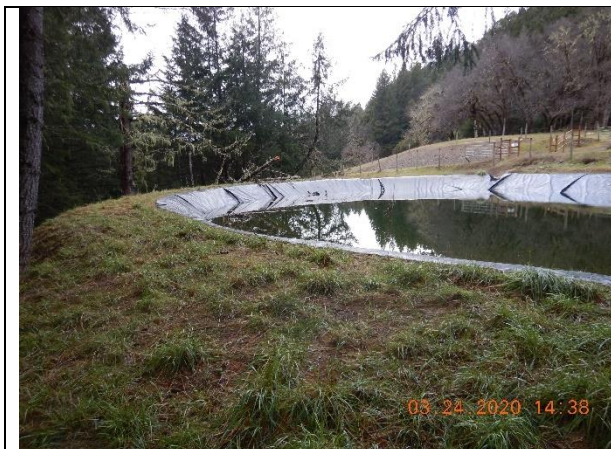
MR21: I observed the pond mentioned in **MR20** (Photo 21).

Photo 21 – Pond 4

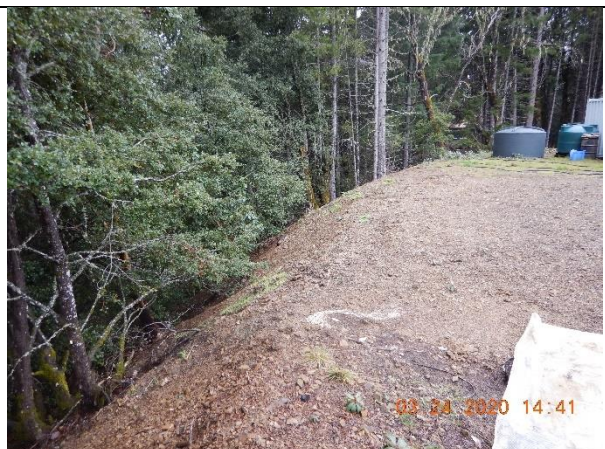
MR22: I observed a steep, unstable cultivation area (Photo 22).

Photo 22 – Steep side slope of cultivation area

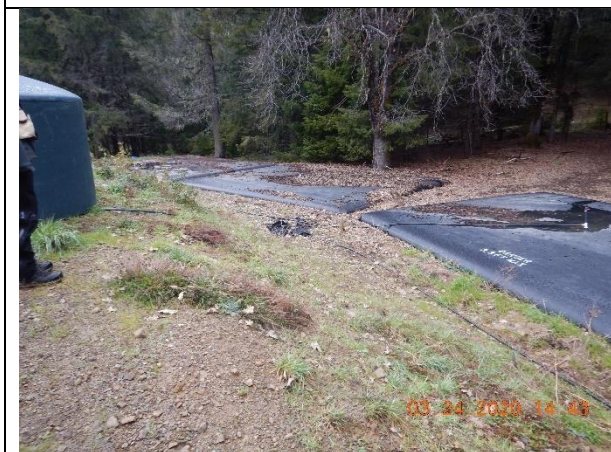
MR23: I observed three water bladders lacking secondary containment (Photo 23).

Photo 23 – Three water storage bladders

6. Discontinue use of water storage bladders or install secondary containment systems with sufficient capacity to capture 110 percent of each bladder's maximum possible contents in the event of bladder failure per the CANGO.
